Distal humeral plating of an intramedullary nail periprosthetic fracture using a miss-a-nail technique: a case report

Cases Journal 2009, 2:6704 doi: 10.1186/1757-1626-2-6704

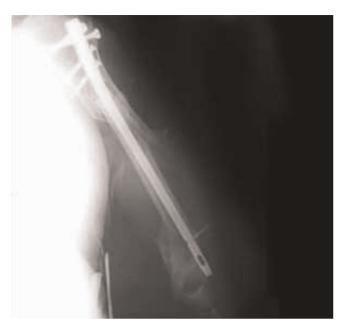
Figure 1. AP radiograph of the periprosthetic fracture of left humerus.

On examination he had a tender, swollen upper arm. The injury was a closed injury with no distal neurovascular deficit. Four years prior to this episode, he had sustained a left segmental humeral fracture requiring stabilization with a Polarus Plus intramedullary humeral nail. Radiographs showed a displaced distal humeral periprosthetic fracture about the Polarus Plus nail with pull out of the distal locking screws (Figure 1).

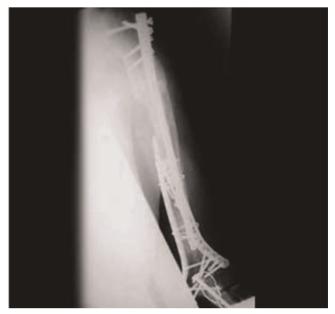
Figure 6. Lateral radiograph of left elbow post fixation with elbow in full extension.

Post operative radiographs showed fractures to have united satisfactorily (Figures 5-7). The patient was very pleased with the outcome, and was able to continue being independent in his activities of daily living.

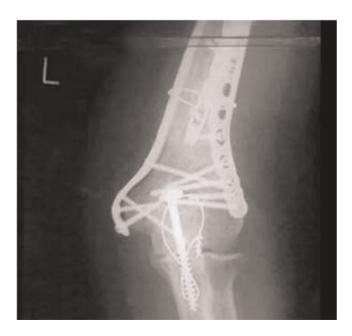
Figure 5. AP radiograph of left elbow post fixation.

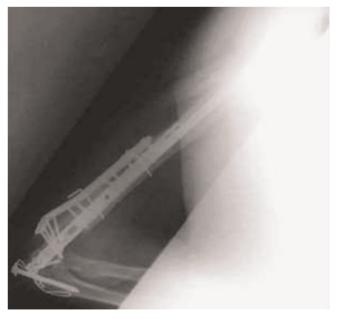
Figure 7. Lateral radiograph of left elbow post fixation with elbow in flexion.
