Case report

Early loosening and secondary dislocation due to a broken trochanteric osteotomy wire following a Charnley total hip arthroplasty: a case report

Cases Journal 2009, **2**:7117 doi: 10.1186/1757-1626-2-7117

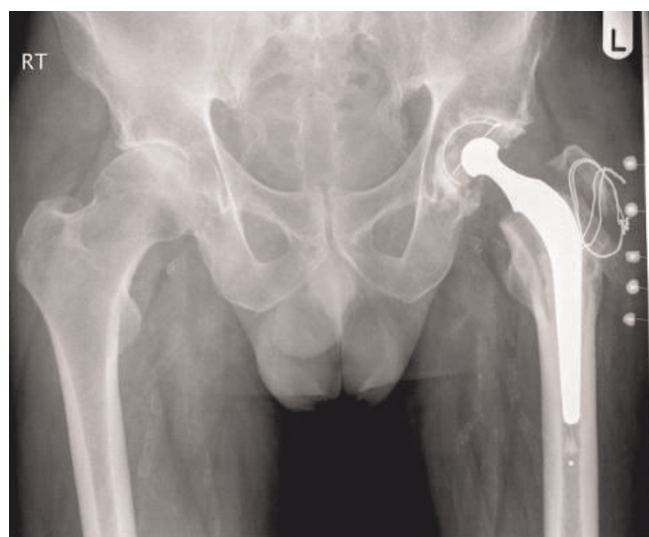
Figure 1. Post Charnley left total hip replacement plain X-ray of the pelvis.

A 61 year old British white male was admitted with a dislocation of a left Charnley total hip arthroplasty which was performed in 2005 for a subcapital fracture of the left neck of femur. The operation was successful for three years and the patient was doing well. Immediate post operative plain X-ray of the pelvis was satisfactory (Figure 1). In March 2008 the patient presented with a sudden left hip pain while was getting into bed and was unable to weight

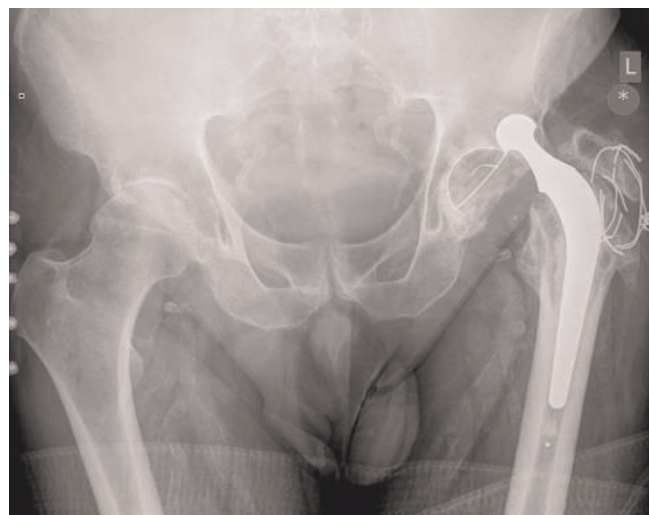
Plain X-ray of the pelvis showed a dislocated left Charnley total hip arthroplasty and it also showed a foreign body in the hip joint (broken wire) (Figure 2). The hip was reduced under general anaesthesia. The hip joint was stable up to 90 degrees flexion and 10 degrees of internal rotation.

Figure 2. Plain X-ray of the pelvis showing a dislocated left hip with a broken wire in the left hip.

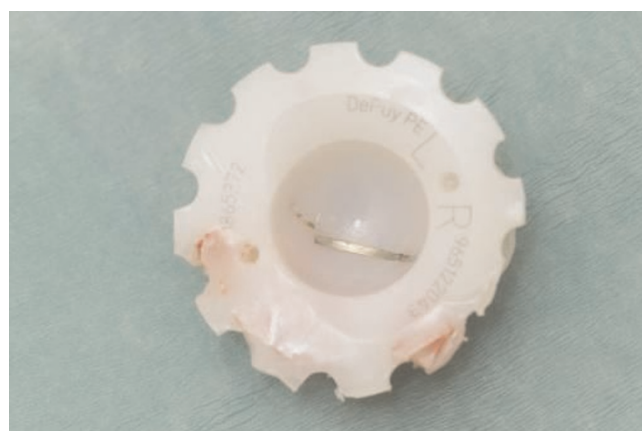
In April 2008, the patient had a revision of left Charnley total hip arthroplasty with a good result. Intraoperatively, a broken wire was found embedded in the polyethylene acetabular component and the polyethylene bearing surface was found to be worn (Figure 3).

Figure 3. The acetabular component with a worn bearing surface and the broken wire embedded in it.

The interposition of broken trochanteric wires in the hip joint post Charnley total hip arthroplasty can cause a third body effect leading to early loosening and early wear of the prosthetic components leading to dislocation of the hip. It is a complication that should be considered when performing a Charnley total hip arthroplasty which might necessitate an early revision surgery.
